03/18/89 Evergreen International Airlines

Official Accident Report Index Page

Report Number	NTSB/AAR-90/02
Access Number	PB90-910402
Report Title	Evergreen International Airlines, McDonnell Douglas DC-9-33F, N931F, Saginaw, Texas, March 18, 1989
Report Date	April 23, 1990
Organization Name	National Transportation Safety Board Office of Aviation Safety Washington, D.C. 20594
WUN	5094A
Sponsor Name	NATIONAL TRANSPORTATION SAFETY BOARD Washington, D.C. 20594
Report Type	Aircraft Accident Report March 18, 1989
Distribution Status	This document is available to the public through the National Technical Information Service, Springfield, Virginia 22161
Report Class	UNCLASSIFIED
Pg Class	UNCLASSIFIED
Pages	85
Abstract	This report explains the crash of an Evergreen International Airlines McDonnell Douglas DC-09-33F, N931F, in Saginaw, Texas, on March 18, 1989. The safety issues discussed in the report include the cargo door closing procedures on DC-9 airplanes; the external cargo door markings on DC-9 airplanes; the door warning switch electrical wiring on DC-9 airplanes; and the actions of the carrier and the Federal Aviation Administration concerning these issues preceding the accident.

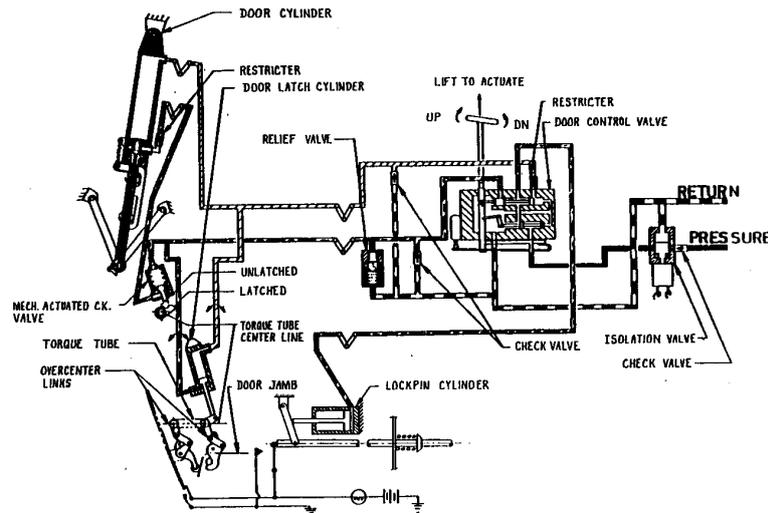
Figure 1.--Hydraulic routing within the cargo door hydraulic system.

1. The cargo door control valve - This valve was found in the "valve neutral" position (as opposed to the "door open" or the "door closed" position) within the wreckage. Damage to the valve did not allow testing in the "door open" or "door closed" positions. The valve was disassembled at its manufacturer's facility and no anomalies were found. [See Figure 1](#) for a cut-away diagram of this valve in its three operating positions.

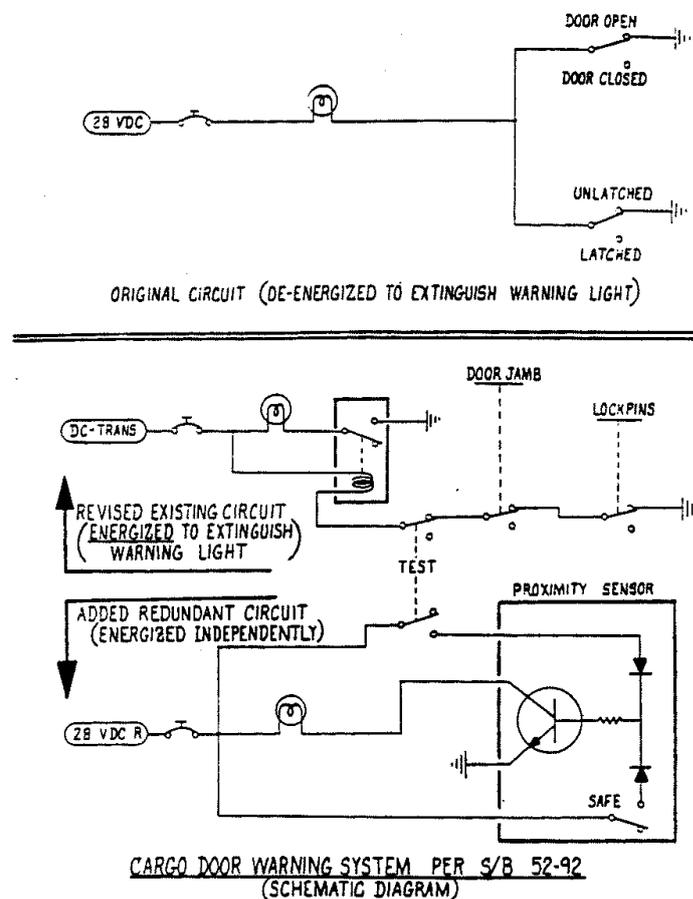
Figure 3.--Cargo door warning switch electrical diagrams.

The SB modification eliminates an undesirable failure mode of the original cargo door cockpit warning light system wherein a failure of either the door jamb switch or the lockpin switch to close will remain undetected and the cockpit warning light will appear to function normally; that is, the light would illuminate when the other functional switch closes and extinguish when it opens. Thus, if the lockpin switch is the one failed, the door will appear safe when closed even though it is not fully latched and locked. The modification to the existing circuit consists of adding a relay which must be energized with 28 volts dc to extinguish the cockpit warning light. The door jamb and lockpin switches are rewired in a series circuit so that electrical continuity through both switches will energize the relay. With the logic of the switches inverted and placed in series instead of parallel, a failure of either switch to close will result in an illuminated warning light.

The cargo door latch limit switch/wire/cannon plug assembly was wired into the door warning system in the original configuration without the benefit of SB 52-92 improvements. The original configuration called for this switch and the door jamb limit switch to be connected in parallel to the MAIN CARGO DOOR open warning light on the annunciator panel in the cockpit. [See figure 3.](#) The female connector to this switch was damaged and a small amount of corrosion on the connector was evident. The unit was x-rayed and disassembled. The L-lever of the switch would not fully depress the micro-switch plunger of the assembly and electrical continuity could not be established.

- g. SB 52-92 - Issued on April 7, 1976, with revision 2 on November 21, 1985 - This SB recommended a modification of the original cargo door cockpit warning light system electrical circuit and the addition of a redundant independently energized warning light and circuit.
